## **Field Asset Management Inventory Project: Summer FY 12**

### *Methodology of Data Collection*

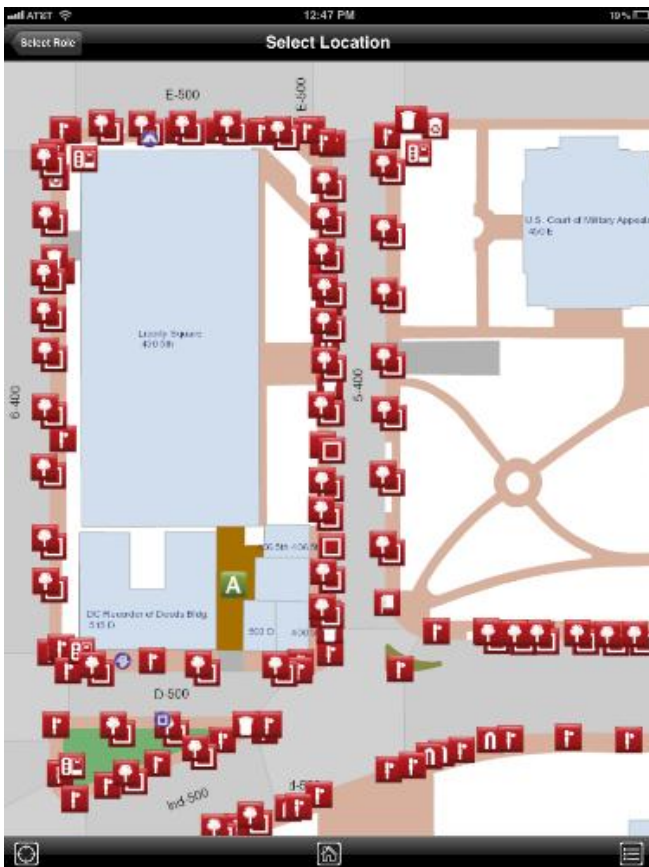
Image 1.1 Non-Inventoried Assets

As seen below in the *Table 1.0* staff surveyed 98% of these assets, with the exceptions of areas around CityCenter DC and Reservation 72 (Chinatown Park) both currently under construction, along with locations near I-395 service roads. Of the assets that were surveyed, staff was able to identify various relative conditions and ensure that the asset had no related problem associated with it. After each item was checked the asset icon on the application would then turn green (from its initial red), assuring that it had been properly surveyed (see Images 1.1 and 1.2). While inventorying this set list of items, PSM staff also made numerous GIS edits in the field totaling over 400 during the month of August. Furthermore, PSM staff and SAMs also documented conditions that were not included on the list ensuring that issues still were reported and addressed during the project.

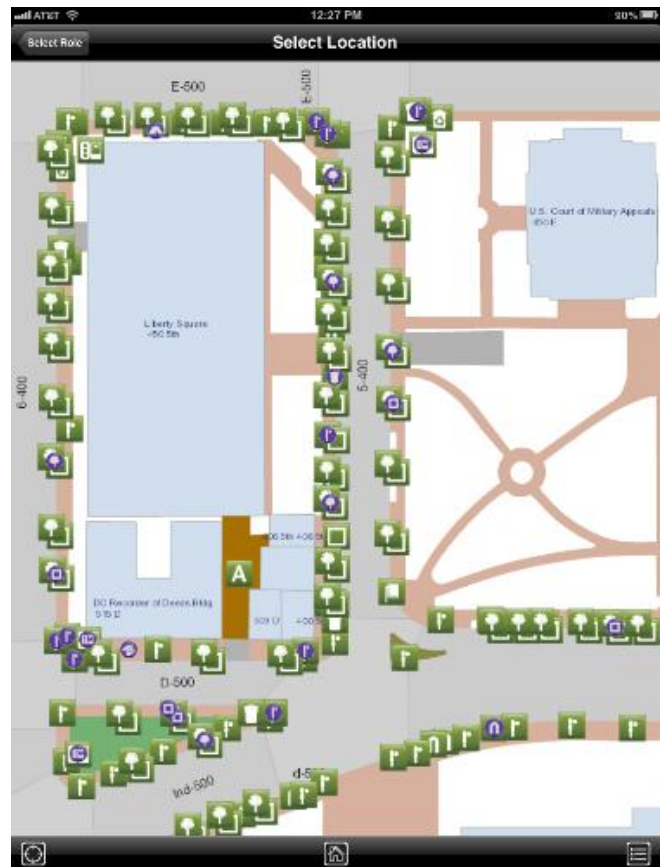
Image 1.2 Inventoried Assets

The findings of the inventory illustrate that several of the permanent assets are indeed in relatively good condition with nearly 93% of the total number surveyed not having a problem attached to it. Nonetheless, there over 700 unique conditions reported during the project. Of these assets bike racks (2.4%) and catch basins (1.8%) tallied the lowest number of identified conditions, while traffic control boxes had the highest number of documented issues relative to the number of assets inventoried at 20.2%. Also, staff uncovered that over 25% of the permitted sidewalk vendors were not at their assigned locations or missing from the area. This is likely due to a few different variables including time of day, success of business, or poor accuracy of previous permitted locations. Moreover there were nearly 300 tree and tree box issues identified which accounts for 38.2% of the total number of conditions reported, while internally managed conditions like trash and recycling receptacle problems were around 20% of the total number. Several of these receptacle issues have minimal maintenance, such as cleaning or repainting of the canister which attributed to the large number of conditions related to them. Additionally, staff identified many of the conditions regarding street poles to be exposed wiring due to missing base covers, rusting and re-painting needed, or light timing or öday burnerö issues.
