Walkability Assessment: Entertainment Zone

Methodology

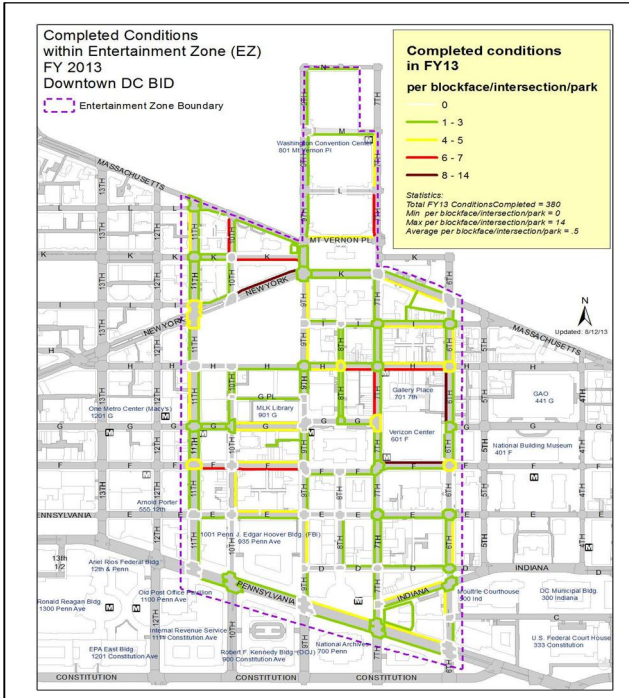
Map 1.0 ETZ Completed Conditions

or fewer conditions associated with it. These are illustrated in Map 1.0 and Map 1.1 below. Also, the density of issues reported in the ETZ lie in the heart of the 7th St Corridor and areas adjacent to the Verizon Center.

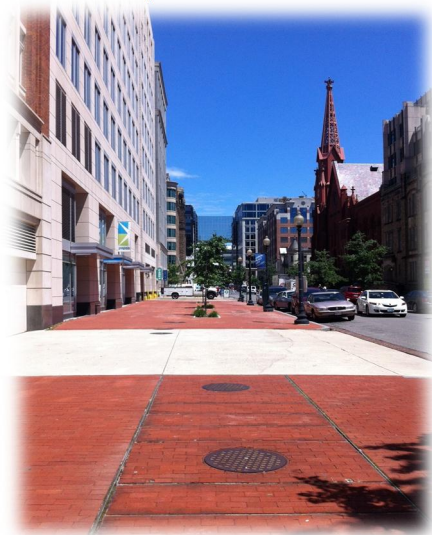
700 Block of 8th St

Block was absent of items blocking pedestrian right-of-way (ROW), had clean sidewalks, smooth roadways and zero quality of life issues such as panhandling or solicitation

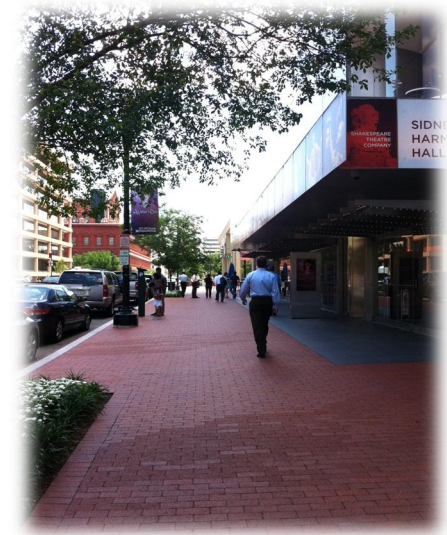
600 Block of F St

Block had substantial space for pedestrians, limited amount of roadway hazards, a minute level of disorder with one homeless individual documented.

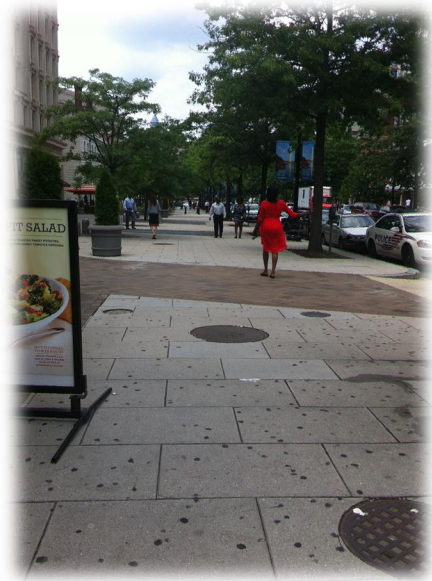
600 Block of Indiana Ave

Location had several sidewalk issues including trip hazards and gum stains; crowded sidewalk with vendors and construction activity

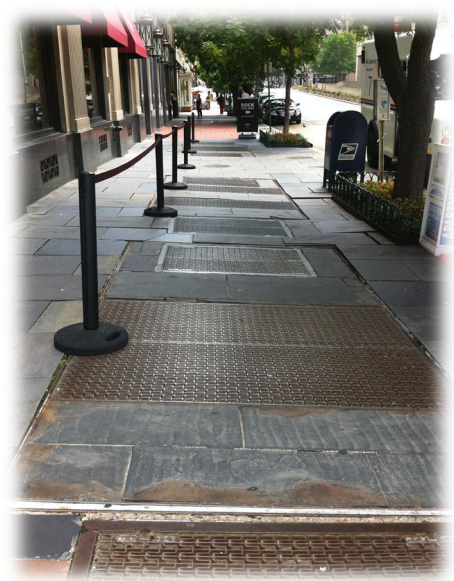
900 Block of E St

Pavers on both sides of the block posed trip hazards; crowding of signage and other elements; panhandling and homelessness present
